2017 Reserve Study & Maintenance Plan

Arbor Terrace Homeowners

Sherwood, Oregon

February 9, 2017

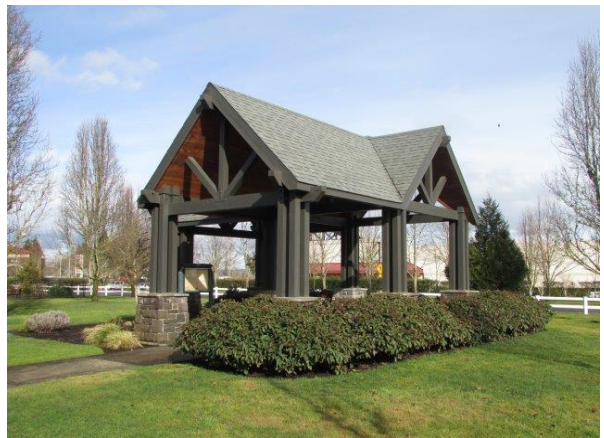
Gazebo-Bench-Replace	2	Each	\$ 1,500.00	\$ 3,604	2005	20	2025	9	No
Gazebo-Kiosk	1	Total	\$ 500.00	\$ 542	2005	15	2020	4	No
Gazebo-Paint	1	Total	\$ 1,100.00	\$ 1,193	2013	7	2020	4	No
Gazebo-Roof	7	Squares	\$ 350.00	\$ 3,259	2005	25	2030	14	No
Comments: Budget cost of replacement is based on removal and replacement of single layer roof with a 30 year composition shingle.

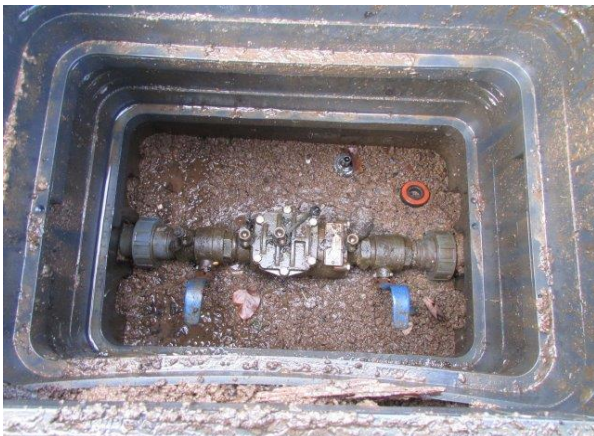
Landscape-Irrigation-Valves & Controllers	1	Total	\$ -	\$ -	2017	50	2067	51	No
Comments: Replaced as needed by landscape contractor. Paid from Operating Budget									
Landscape-Renovation-2017	1	Total	\$ 54,145.00	\$ 55,260	2015	2	2017	1	Yes
Comments: 2017: Board reported major landscape renovations anticipated over the next 3 years (3 phases). Scope of work includes replacing sod throughout neighborhoods, and renovations to the existing irrigation spray heads. Cost estimate provided by Grounds Northwest of \$162,436.									
Landscape-Renovation-2018	1	Total	\$ 54,145.00	\$ 56,399	2015	3	2018	2	Yes
Comments: 2017: Board reported major landscape renovations anticipated over the next 3 years (3 phases). Scope of work includes replacing sod throughout neighborhoods, and renovations to the existing irrigation spray heads. Cost estimate provided by Grounds Northwest of \$162,436.									
Landscape-Renovation-2019	1	Total	\$ 54,145.00	\$ 57,561	2015	4	2019	3	Yes

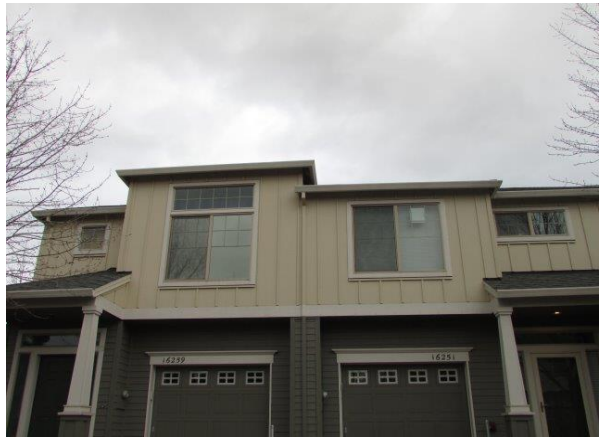
Paint-Exterior	65	Units	\$ 1,500.00	\$ 105,786	2013	7	2020	4	No
<p>Comments: 2017: Observed to be in fair to good condition. Recommend pressure wash to remove mold/mildew buildup. 2013: Exterior painted as part of re-siding project completed by Charter Construction \$53,600 (\$825/unit)</p>									
Rehabilitation Project	65	Units	\$ -	\$ -	2013	50	2063	47	No
<p>Comments: 2013: Rehabilitation project completed by Charter Construction \$1,217,909; Scope was a comprehensive approach to address components of the exterior subject to, or compromised from water intrusion. Brief description of work included: Siding, attic remediation, roof repairs, through penetrations, flashing, and replacement of unprotected windows & doors. Detailed description outlined in Morrison Hirschfield letter dated 10/31/13.</p>									
Roof-Composition	797	Squares	\$ 375.00	\$ 359,079	2000	25	2025	9	No
<p>Comments: Originally constructed in 2005. Base year was adjusted (2000) to reflect current timeline for replacement and address future year roof replacement intervals.</p> <p>Budget cost of replacement is based on removal and replacement of single layer roof with a 30 year composition shingle. Useful life of a 30 year roof should last on average 25 years if properly maintained. Based on observations in 2017, it is our opinion the current roof will only last 20 years as there are signs of moss build-up and weathered shingles. We Recommend that the roof be treated a minimum of bi-annually for moss and debris build up. Insure that tree limbs are trimmed back regularly, at least 6ft from roof edge, as debris from overhanging limbs can significantly reduce the life of a roof due to accumulation of foliage. Debris accumulation will also compromise the effectiveness of the gutter and downspout system to shed water from the building.</p> <p>2017: Roof quantity obtained using satellite imagery (Eagle View Technology) of a typical building extrapolated to derive a total quantity. The year built has been adjusted to 2000 so that a 25 year useful life can be applied and appropriately reflect future years replacement (25 year cycle)</p>

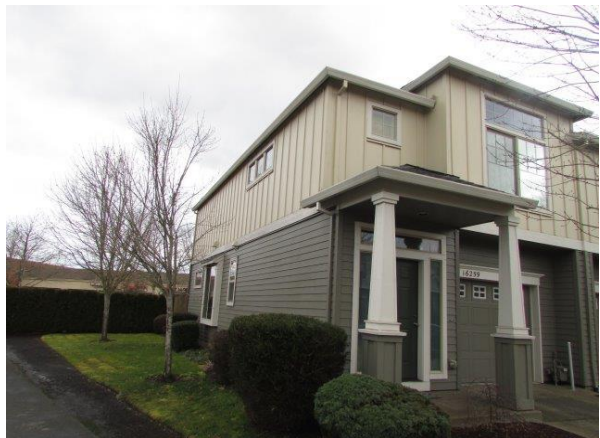
Item Description	# of Items	Unit	Current Item Cost	Future Replacement Cost	Year Built	Useful Life	Year Replace	Life Left	One Time?
Roof-Gutters & Downspouts	6,646	Ln.Ft.	\$ 6.00	\$ 53,051	2005	25	2030	14	No
<p>Comments: At time of replacement consider larger gutters and downspouts to accommodate larger volume of water. Considerations should be taken to coordinate replacement of gutter/downspout system with replacement of roof as there may be some cost savings for coordinating the work.</p> <p>Gutters: 3,526 lf Downspouts: 3,120 lf 2017: Gutter and downspout quantity obtained using satellite imagery (Eagle View Technology) of a typical building extrapolated to derive a total quantity.</p>									
Siding & Trim Repair	65	Units	\$ 200.00	\$ 14,105	2013	7	2020	4	No
<p>Comments: Prior to performing Paint-Exterior, all siding and trim should be carefully inspected, repaired or replaced as needed. Caulking around all doors, windows and trim should be performed.</p>
