2017 Reserve Study & Maintenance Plan

Arbor Terrace Homeowners

Sherwood, Oregon

February 9, 2017

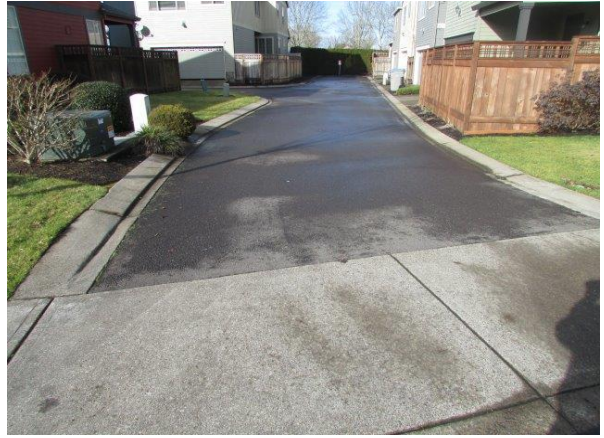
Item Description	# of Items	Unit	Current Item Cost	Future Replacement Cost	Year Built	Useful Life	Year Replace	Life Left	One Time?
Paving-Asphalt-Overlay Comments: Under average traffic conditions, and regular and adequate cycles of repair, crack seal and sealcoating, a properly installed asphalt pavement should last 30–40 years. Heavy truck traffic like garbage trucks can accelerated damage to the traffic lane. Sealcoating should be applied within 2 years of installation date.	20,700	Sq.Ft.	\$ 1.75	\$ 53,366	2005	30	2035	19	No
Paving-Asphalt-Repair, Crackseal, Sealcoat Comments: Asphalt is a porous material that is deteriorated by water, dirt, oil and sunlight. To protect it from the elements, a sealcoating should be applied as paint is applied to siding. Sealcoating will seal against water, protect against UV rays which break it down, keep the asphalt from drying out and extend its useful life. It is highly recommended that two coats be applied to achieve the estimated useful life. Restriping (if applicable) included in the cost.	20,700	Sq.Ft.	\$ 0.25	\$ 5,282	2012	5	2017	1	No

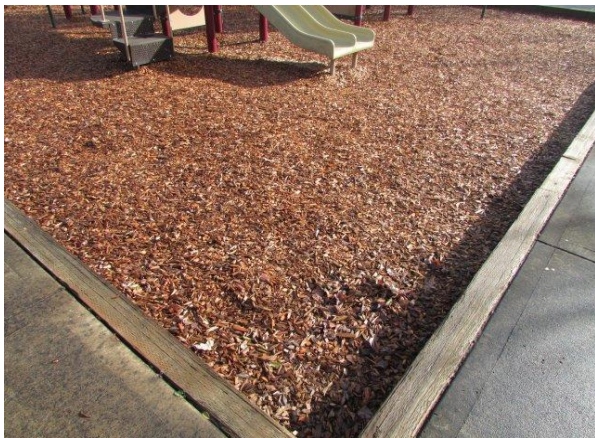
Playground-Barkdchips Comments: Paid from Operating Budget	1	Total	\$ -	\$ -	2017	50	2067	51	No
Playground-Bench	4	Each	\$ 1,250.00	\$ 6,007	2005	20	2025	9	No
Playground-Fence-Metal-Paint Comments: 2013: Completed with Tamarack Units (\$4.75/lf)	240	Ln.Ft.	\$ 9.50	\$ 2,424	2013	6	2019	3	No
Playground-Fence-Metal-Replace	240	Ln.Ft.	\$ 60.00	\$ 26,012	2005	40	2045	29	Yes
Playground-Play Structure/Equipment	1	Total	\$ 30,000.00	\$ 39,912	2005	25	2030	14	No
Playground-Wood Borders Comments: Wood (Pressure treated) borders around play structure.	160	Ln.Ft.	\$ 18.00	\$ 3,832	2005	25	2030	14	No
Retaining Wall-Rock Comments: Originally constructed in 2005. Base year reflected (2017) is start of repair budget cycle. Use this fund to inspect, remove and/or replace selected sections as needed over a 10 year period; list year, work done and cost here.	1	Total	\$ 2,000.00	\$ 2,503	2017	10	2027	11	No
Signs-Street Comments: Owned and maintained by the city	1	Total	\$ -	\$ -	2017	50	2067	51	No

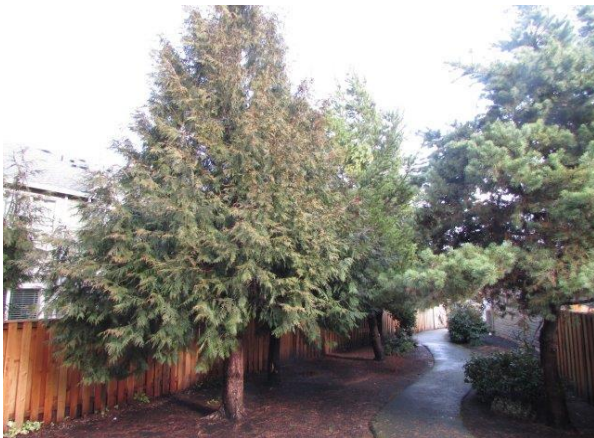
Storm Drains Comments: Owned and maintained by the city	1	Total	\$ -	\$ -	2017	50	2067	51	No
Treework Comments: Treework/Arborist work completed yearly and paid from Operating Budget. Have trees inspected by arborist and perform corrective pruning as needed to keep tree limbs at least 6' away from buildings. Tree limbs overhanging roofs and decks will damage and shorten the useful life of that component	1	Total	\$ -	\$ -	2017	50	2067	51	No

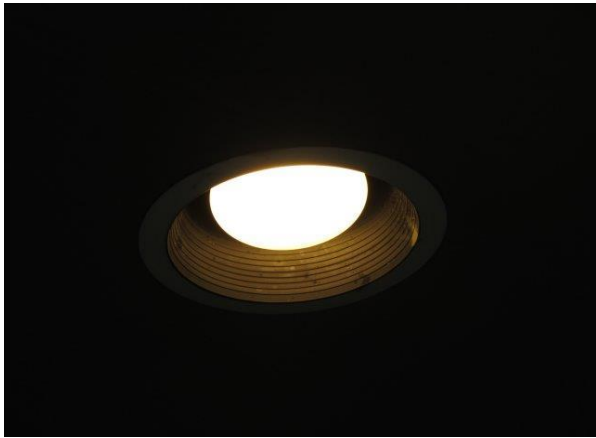
Item Description	# of Items	Unit	Current Item Cost	Future Replacement Cost	Year Built	Useful Life	Year Replace	Life Left	One Time?
Electrical & Plumbing-Systems	1	Total	\$ -	\$ -	2005	60	2065	49	No
<p>Comments: It is assumed that the electrical and plumbing systems have been installed in accordance with local building codes/standards. There have been no reports of large scale repair/failure occurring or anticipated.</p> <p>Repairs and replacements of individual components of these systems are completed as needed and paid from Operating Budget. Widespread failure of these systems is uncommon and global replacement is generally not warranted. If it is determined, upon inspection by a professional, that a new system, or major repair/replacement is warranted, the cost and remaining useful life should be added per contractor recommendation.</p>									
Lights-Exterior	130	Fixtures	\$ 65.00	\$ 11,242	2005	25	2030	14	No

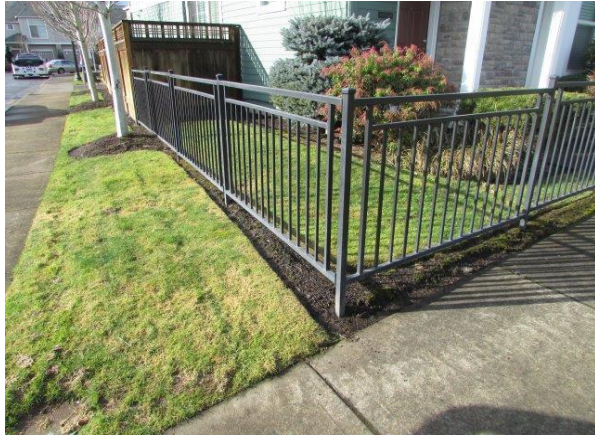
Item Description	# of Items	Unit	Current Item Cost	Future Replacement Cost	Year Built	Useful Life	Year Replace	Life Left	One Time?
Fence-Metal-Paint	2,600	Ln.Ft.	\$ 9.50	\$ 26,258	2013	6	2019	3	No
<p>Comments: 2017: Overall condition observed to be in good condition. Touchup and miscellaneous repairs paid from Operating Budget. 2013: Painting of all metal fence at Tamarack units and playground (240 lf) completed \$13,500 (\$4.75/lf)</p>									
Fence-Metal-Replace	2,600	Ln.Ft.	\$ 60.00	\$ 281,797	2005	40	2045	29	Yes
<p>Comments: Remove and replace all metal fence and gates 2017: Overall condition observed to be in good condition. Touchup and miscellaneous repairs paid from Operating Budget.</p>
